NASA TN D-8150

PERFORMANCE OF LI-1542 REUSABLE SURFACE
INSULATION SYSTEM IN A HYPERSONIC STREAM

*L. Roane Hunt, John L. Shideler,
and Irving Weinstein*

*Langley Research Center
Hampton, Va. 23665*

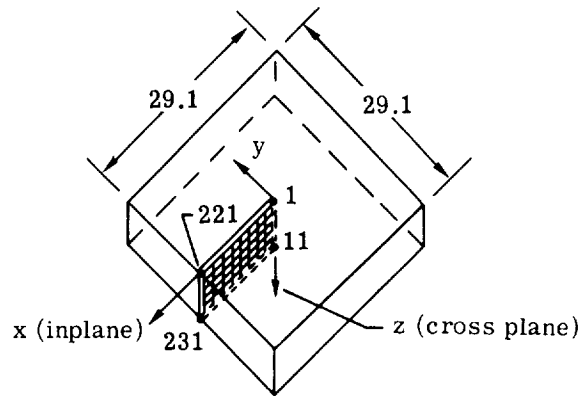
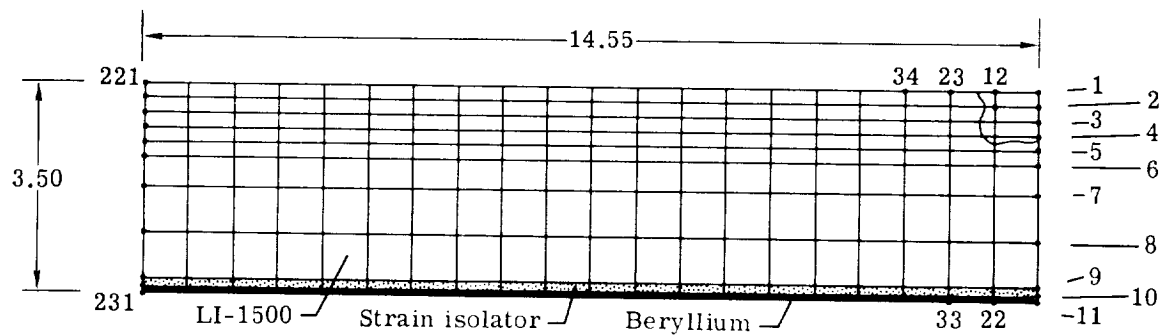
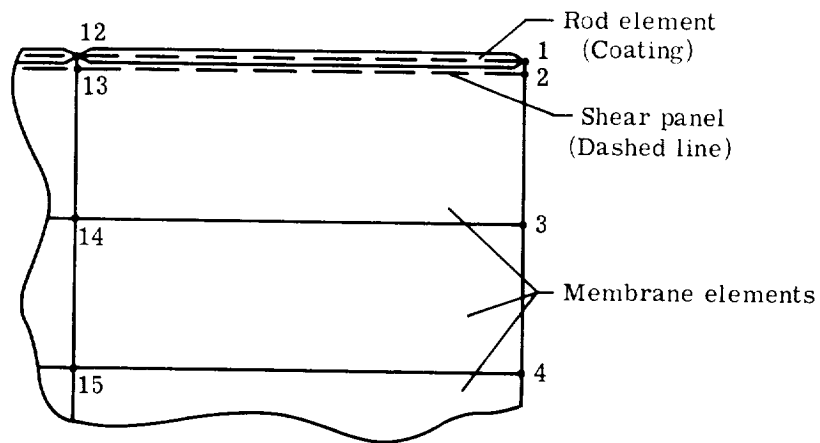
Figure 33.- Finite-element model of LI-1542 tile. Dimensions are in centimeters, numbers by solid circles indicate joint numbers.

Figure 33 shows a typical LI-1542 RSI tile and the portion of the tile which was modeled. A vertical slice of half of the tile (see fig. 33(a)) with a thickness arbitrarily selected to be 0.025 cm was modeled with finite elements as shown in figure 33(b). This approach to modeling the tile assumes that the panel is in a state of plane stress. Conditions of symmetry were imposed along the edge from joints 1 to 11, and joint 11 was completely restrained from translation or rotation. The bottom of the beryllium panel (joints 11, 22, 33, . . . , 231) was held flat but was allowed to translate in the x-direction. All elements are quadrilateral membrane elements unless otherwise specified. Figure 33(c) shows the finite-element grid that included a rudimentary model of the thin coating. The membrane elements in the top row were replaced with rod elements which were connected to the membrane elements by shear panels. The shear panel elements transmit load between the rod and membrane elements and were assigned a high modulus of elasticity to simulate a rigid attachment between the coating and the insulation. Short rods (not shown in fig. 33(c)) were also used to stiffen the short sides of the shear panel elements, for example, between joints 1 and 2, 12 and 13, etc. For simplicity, the sidewall coating was not modeled. The sidewall coating was assumed to have negligible effect on stresses in the top surface, since the coating, observed after test 4, was uniformly crazed over the top surface. However, other environments to which the panel might be exposed such as a cold soak in space may result in significant effects from the sidewall coating.

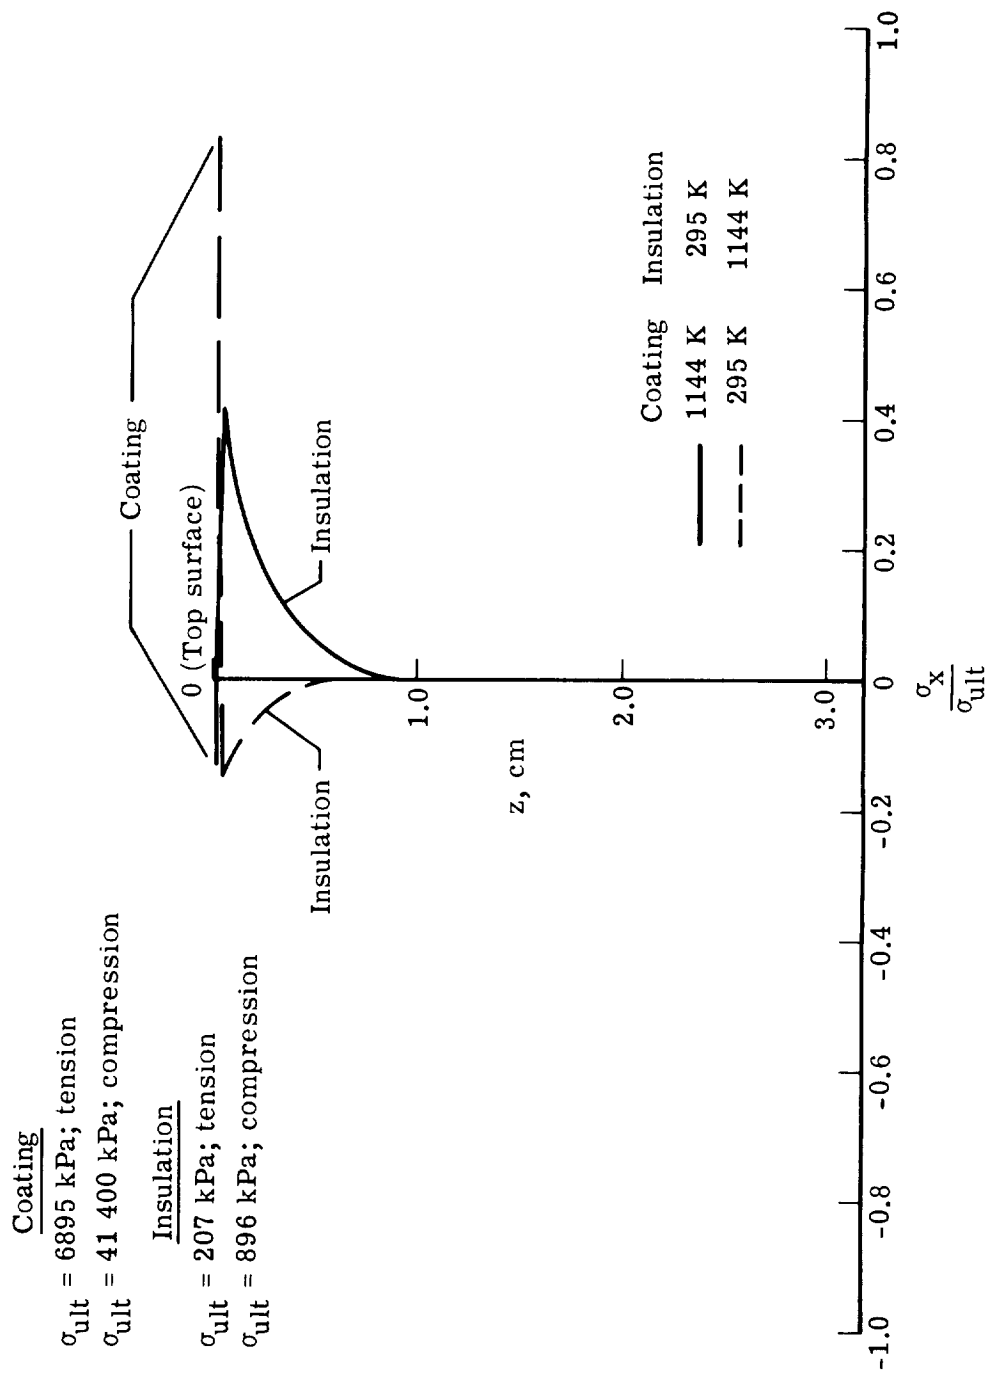
Figure 34.- Maximum stress assuming extreme temperature conditions.

The ratios of the maximum thermal stresses in the coating and in the insulation to their respective ultimate stresses were calculated for the two extreme temperature distributions and are shown in figure 34. Ultimate stresses for the coating and insulation in both tension and compression are given in the figure. The maximum stress in the coating occurs at the center of the tile, and the maximum stress in the insulation occurs at the tile edge. Calculated stresses in the coating and the insulation are not great enough to cause failure in either tension or compression. However, the maximum coating stress is 83 percent of its ultimate tensile stress. This thermal stress, in combination with stresses unaccounted for by the analysis such as those produced by aerodynamic pressure, dynamic loads, or those due to nonuniform thickness of the coating, may have been sufficient to cause the coating to craze.

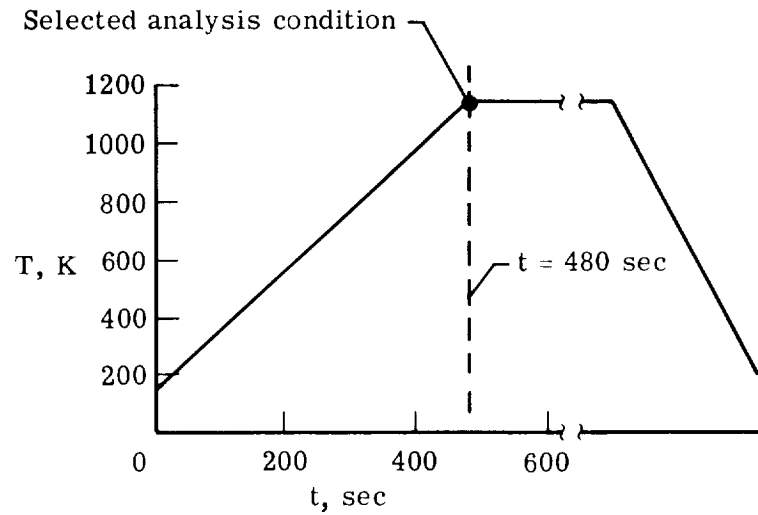
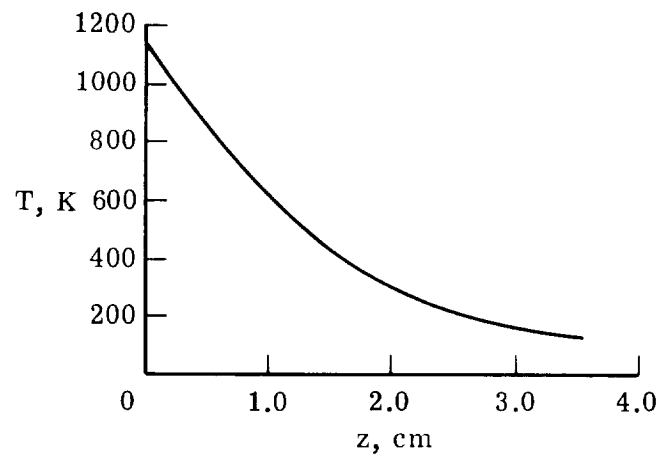
Figure 35.- Typical shuttle entry temperatures.

A thermal stress analysis was conducted on the tile with temperature distributions representative of a space shuttle entry mission. The first temperature distribution selected for analysis was a uniform 160 K cold soak condition. A second temperature distribution selected was nonlinear and was calculated based on the typical surface temperature history for a space shuttle entry shown in figure 35(a). During entry, the surface temperature increases from a cold soak condition in space at 160 K to 1144 K in about 480 seconds. The condition identified in figure 35(a) at $t = 480$ was selected for analysis because it offers potentially critical thermal stresses arising from a combination of constrained thermal growth, and a large nonlinear temperature gradient through the thickness. A temperature gradient was calculated for the time at 480 seconds by use of the MITAS thermal analysis computer program described in appendix A and is shown in figure 35(b).

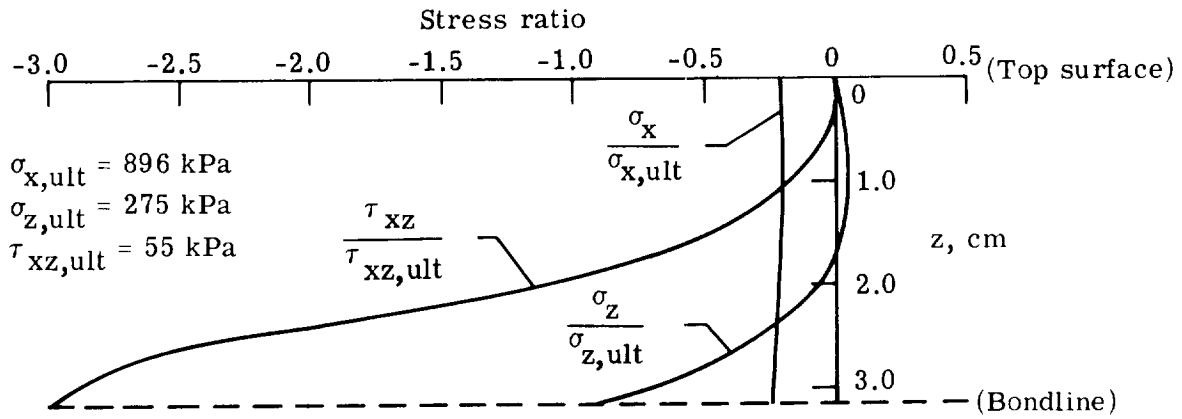
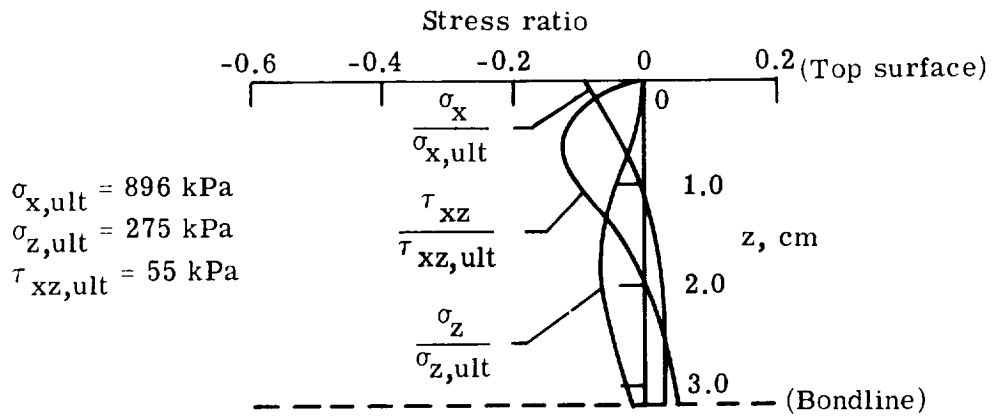
Figure 36.- Maximum RSI stress with RTV-560 strain isolator, coating neglected.

Thermal stresses arising from the 1144 K to 160 K temperature gradient are given in figure 36(b). All stresses are well below critical values. The low stresses result, in part, from the assumption that the RTV-560 undergoes stress relaxation prior to the tile being exposed to entry conditions. This assumption is based on data which show that RTV-560 undergoes a 90-percent stress relaxation at 160 K, most of which occurs in a relatively short period. (See ref. 17.)

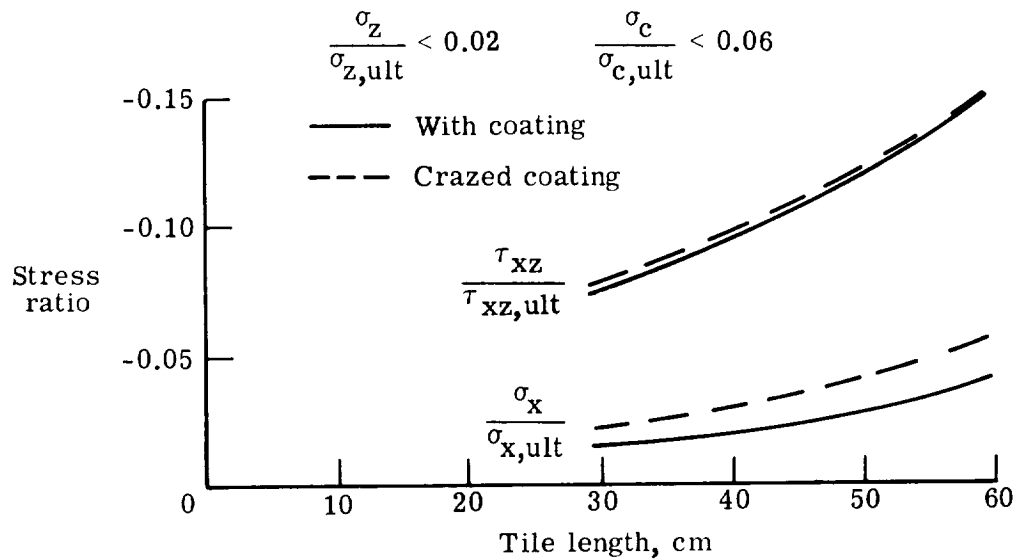
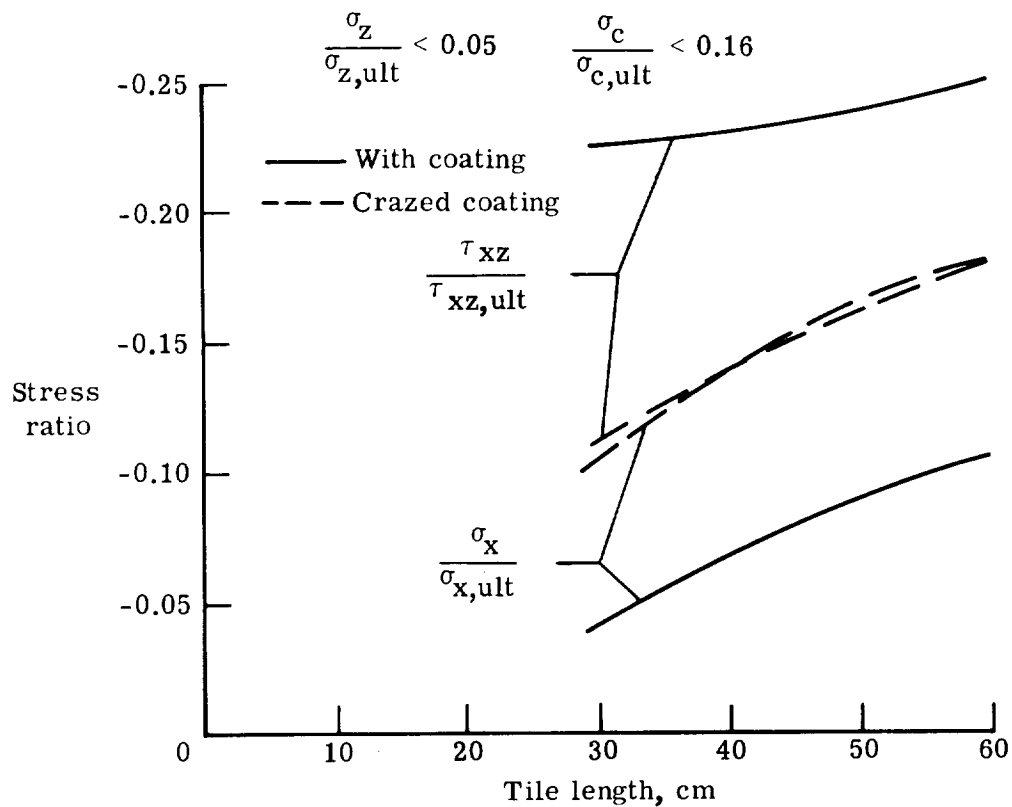
Figure 38.- Variation of maximum RSI stress with tile size.

An indication of the effect of tile size on thermal stresses is shown in figure 38. Figure 38(a) shows the maximum inplane stress σ_x and shear stress τ_{xz} as a function of tile size for the cold soak condition, and figure 38(b) shows the same stresses for the entry temperature gradient given in figure 35(b). The solid lines are stresses for the coated tile, and the dashed lines represent the stresses for the tile with a crazed coating. In all cases the stresses increase with increasing tile size. The σ_x stresses shown in figure 38(a) are at the bondline of the RSI. The stresses in the RSI with coating are less than those in the tile with a crazed coating. The coating causes additional compressive stresses in the RSI at the top of the tile and changes the stress distribution so that the maximum stress at the bondline is reduced. In figure 38(b) the maximum σ_x stresses are also compressive but are at the top of the RSI. Because the coating has a higher coefficient of thermal expansion than the insulation, the coating causes tensile

The effect of the coating on shear stresses is small for the cold soak condition (fig. 38(a)), but it is larger for the entry temperature gradient condition (fig. 38(b)). The maximum shear stresses occur near the tile edge and near the bondline. The coating is subjected to a large temperature change which combines with a high coefficient of thermal expansion to increase the thermal growth of the tile. This increase in thermal growth causes the increase in shear stress.

Examination of figure 38 indicates that the thermal stresses for a 60-cm-square tile are well within acceptable limits whether the coating is crazed or not. Thus, even larger tiles are acceptable if a strain isolator such as Nomex is used. It must be recognized, however, that these results do not include the effects of other conditions such as pressure, dynamic and acoustic loads, and the consideration of a real, flexible vehicle substructure. Also, these results neglect the effect of a coating on the side edges of the tile. Each of these factors may significantly affect the maximum allowable tile size.
